Weston & Sampson, PE, LS, LA, PC 1 Winners Circle, Suite 130, Albany, NY 12205 tel: 518-463-4400

#### MEMORANDUM

**SUBJECT:** Wee Wah Lake, Tuxedo Lake, and Pond 3 Trunk Sewer Investigation

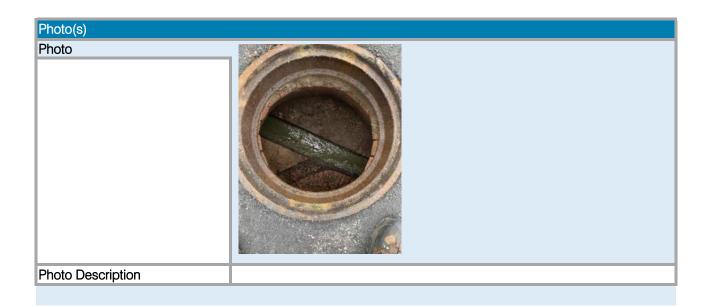
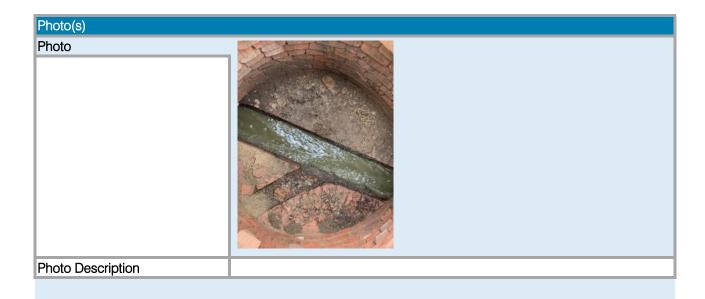
Record: 71	
Client	Village of Tuxedo Park, New York
Project Title	Village of Tuxedo Park Trunk Sewer Inspection
Inspection Date	2021-03-17
Inspector	Anton Patton
Sewer	Village of Tuxedo Park Trunk Sewer
Manhole	EAST-0050
Location	Continental Road
Street or Easement	Street
Surface Type	Asphalt
MH Inspection Status	Inspected
Number of Inverts	3
Signs of Surcharge	NO
Surge Plate	NO
Cover Type	Standard
Cover Material	Cast Iron
Cover Condition	OK
Frame Material	Cast Iron
Frame Condition	OK
Riser Rings	Other
Other Number of Riser Rings	0
MH Cover Elevation At Grade	At Grade
Cover Inflow	None
MH cleaning Required	YES
MH Grease Visible	NO
Roots	NO
Steps	NO
Chimney Material	Brick
Chimney Condition	Satisfactory
Chimney Infiltration	None
Cone Material	Brick
Cone Condition	Satisfactory
Cone Infiltration	None
Wall Material	Brick
Wall Condition	Satisfactory
Wall Infiltration	None
Bench and Invert Material	Brick
Bench and Invert Condition	Satisfactory

Bench and Invert Infiltration	None
Pipe Connection Infiltration	None
Additional Comments	Lateral invert blocked with soil. No flow, appears abandoned
Location Coordinates (click white space below to obtain)

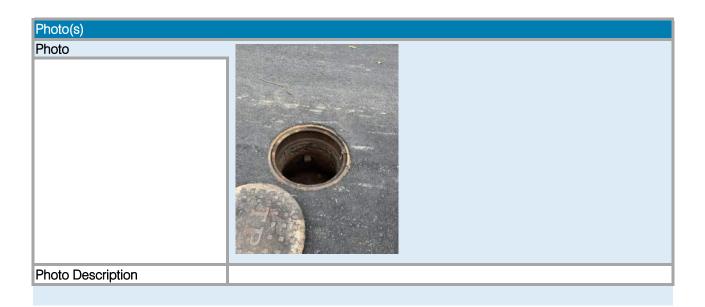
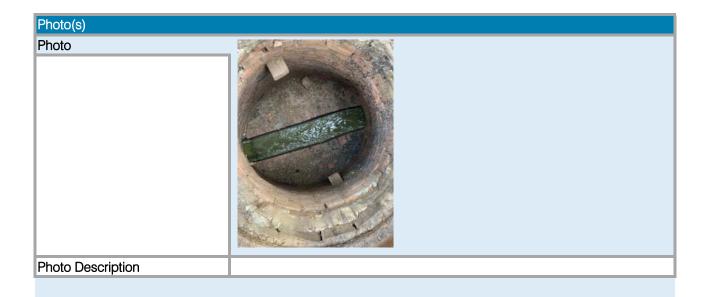
Record: 74	
Necolu. 74	
Client	Village of Tuxedo Park, New York
Project Title	Village of Tuxedo Park Trunk Sewer Inspection
Inspection Date	2021-03-17
Inspector	Anton Patton
Sewer	Village of Tuxedo Park Trunk Sewer
Manhole	EAST-0070
Location	Continental Road
Street or Easement	Street
Surface Type	Asphalt
MH Inspection Status	Inspected
Number of Inverts	2
Signs of Surcharge	NO
Surge Plate	NO
Cover Type	Standard
Cover Material	Cast Iron
Cover Condition	OK
Frame Material	Cast Iron
Frame Condition	OK
Riser Rings	Other
Other Number of Riser Rings	0
MH Cover Elevation At Grade	At Grade
Cover Inflow	None
MH cleaning Required	NO
MH Grease Visible	NO
Roots	NO
Steps	NO
Chimney Material	Brick
Chimney Condition	Needs Repair
Chimney Infiltration	None
Cone Material	Brick
Cone Condition	Needs Repair
Cone Infiltration	None
Wall Material	Brick
Wall Condition	Needs Repair
Wall Infiltration	None
Bench and Invert Material	Brick
Bench and Invert Condition	Needs Repair

Bench and Invert Infiltration	None
Pipe Connection Infiltration	None
Additional Comments	Brick showing signs of aging.
Location Coordinates (click white space below to	
obtain)

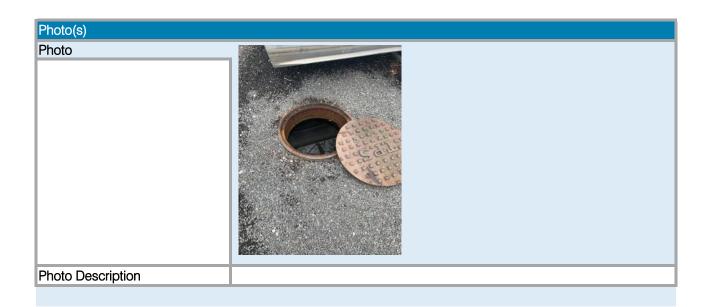
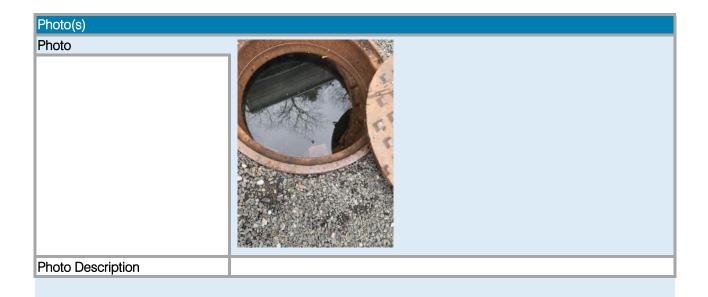
Record: 77	
Client	Village of Tuxedo Park, New York
Project Title	Village of Tuxedo Park Trunk Sewer Inspection
Inspection Date	2021-03-17
Inspector	Anton Patton
Sewer	Village of Tuxedo Park Trunk Sewer
Manhole	EAST-0340
Location	E Lake Road
Street or Easement	Easement
Surface Type	Other
Other Surface Type	Loose small stone, parking lot
MH Inspection Status	Inspected
Number of Inverts	2
Signs of Surcharge	NO
Surge Plate	YES
Cover Type	Standard
Cover Material	Cast Iron
Cover Condition	OK
Frame Material	Cast Iron
Frame Condition	OK
Riser Rings	Other
Other Number of Riser Rings	0
MH Cover Elevation At Grade	Below Grade
Cover Inflow	None
MH cleaning Required	YES
Chimney Material	Brick
Cone Material	Brick
Cone Condition	Needs Repair
Cone Infiltration	Heavy
Wall Material	Brick
Bench and Invert Material	Brick
Additional Comments	Unable to complete survey of manhole due to being full of water. Surge plate working and stopping inflow

from reaching sewer main. There is a hole in the cone just below the frame on the east side allowing stone and water freely into the structure.
Location Coordinates (click white space below to obtain)

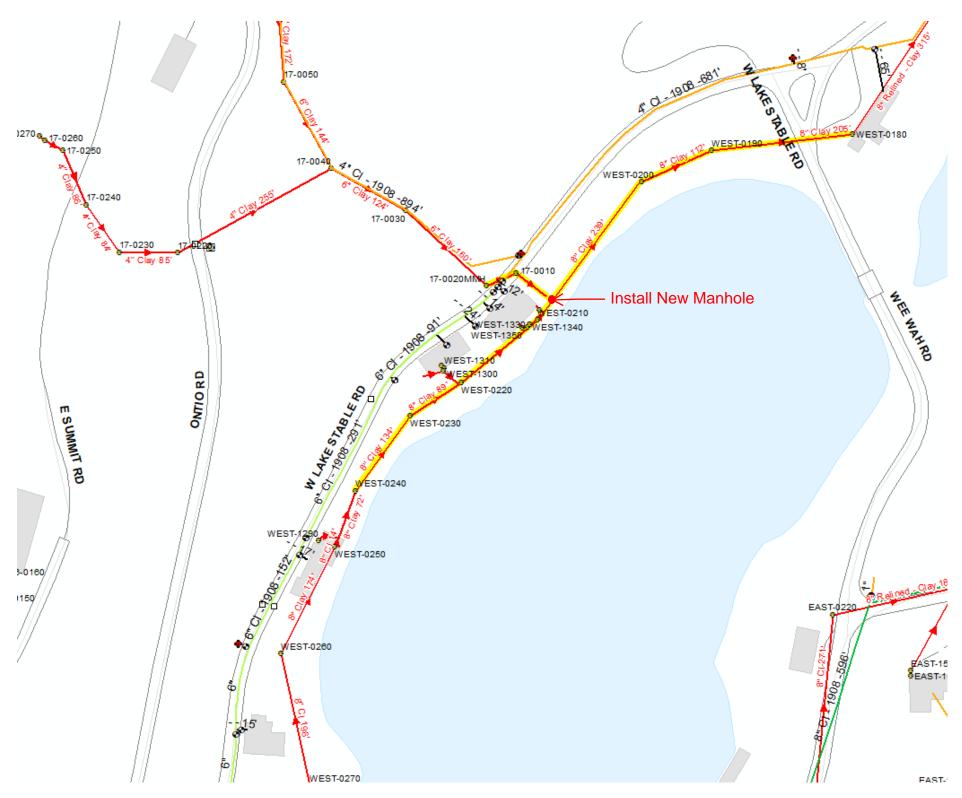
## **Pond 3 Sewer Target Areas**

**Pond 3:** CCTV survey showed a mix a Vitrified Clay Pipe (VCP) and Cast-Iron Pipe from MH West-0180 to MH West-0190 was 8" vitrified clay pipe. There were roots in this pipe that were thick and were in almost every joint on the run. We recommend that all sections of VCP be remediated through Cured-in-Place Pipe lining approaches to prevent future root growth. We also recommend that the manholes be rehabilitated with cementitious mortar and have sealed, gasketed frames and grates installed to prevent sanitary sewer overflows. Finally, the first two sections of Sub-Basin 17 should be CIPP lined, their manholes rehabilitated, and a manhole should be installed at the trunk sewer to eliminate the blind connection to allow for DPW access for maintenance purposes.

<sup>\*</sup> Sections Proposed to be CIPP Lined Highlighted in Yellow
