Weston & Sampson, PE, LS, LA, PC 1 Winners Circle, Suite 130, Albany, NY 12205 tel: 518-463-4400

#### MEMORANDUM

**SUBJECT:** Wee Wah Lake, Tuxedo Lake, and Pond 3 Trunk Sewer Investigation

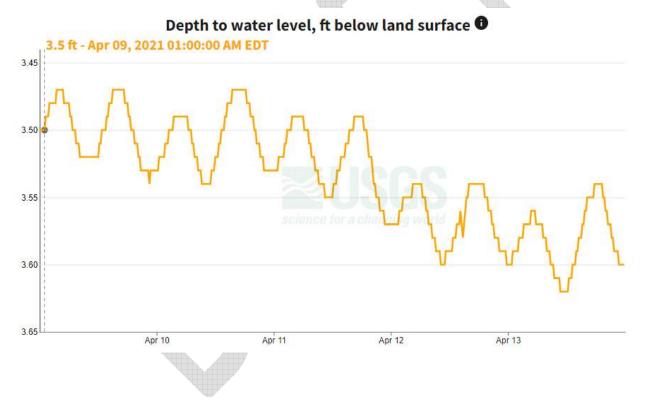
Monitoring location 413428074085701 is associated with a WELL in ORANGE COUNTY, NEW YORK

Based on USGS data from two monitoring wells in the area of Tuxedo Park ground water was found to be between 3.65 and 3.45 feet below the surface at the time of flow isolation.

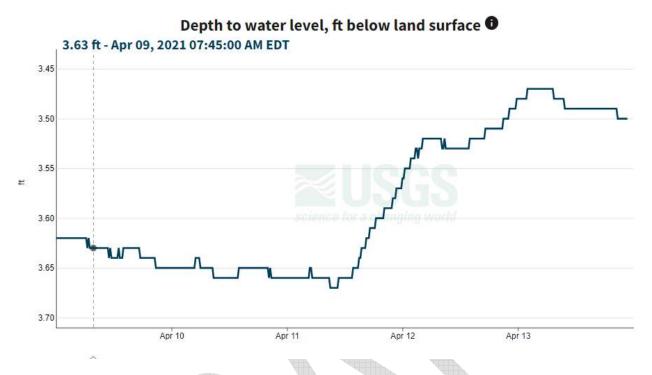
#### Monitoring location 410207074270001 is associated with a WELL in MORRIS COUNTY, NEW JERSEY

The sanitary sewers are typically below 3.5 feet within the Village so they could likely have been under the influence of groundwater at the time of the flow isolation.

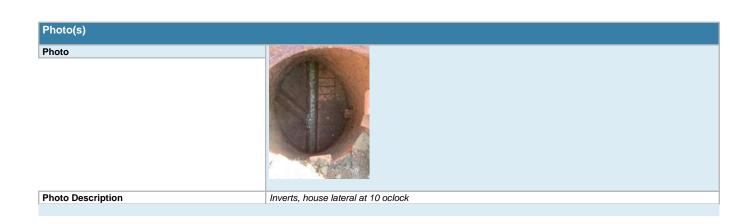
Record: 25	
Client	Village of Tuxedo Park, New York
Project Title	Village of Tuxedo Park Trunk Sewer Inspection
Inspection Date	2021-03-23
Inspector	James Salaway
Sewer	Village of Tuxedo Park Trunk Sewer
Manhole	04-0010MMH
Location	E Lake Road
Street or Easement	Other
Other Manhole Location	Yard up from road approx. 75'
Surface Type	Grass
MH Inspection Status	Inspected
Number of Inverts	2
Signs of Surcharge	NO
Surge Plate	NO
Cover Type	Standard
Cover Material	Cast Iron
Cover Condition	OK
Frame Material	Cast Iron
Frame Condition	OK
MH Cover Elevation At Grade	At Grade
Cover Inflow	None
MH cleaning Required	NO
MH Grease Visible	NO
Roots	NO
Steps	NO
Steps Condition	Needs Repair
Chimney Material	Brick
Chimney Condition	Needs Repair
Chimney Infiltration	None
Cone Material	Brick
Cone Condition	Needs Repair
Cone Infiltration	None
Wall Material	Brick
Wall Condition	Satisfactory
Wall Infiltration	None
Bench and Invert Material	Brick

Bench and Invert Condition	Satisfactory
Bench and Invert Infiltration	None
Pipe Connection Infiltration	None
Location Coordinates (click white space below to	Latitude: 41.200460,
obtain)	Longitude:-74.201818,
,	Altitude:178.572979,
	Speed:0.025725,
	Horizontal Accuracy:3.736518,
	Vertical Accuracy:7.478966,
	Time:03/23/2021 10:54:07 EDT

Photo	
Photo Description	Cover and frame

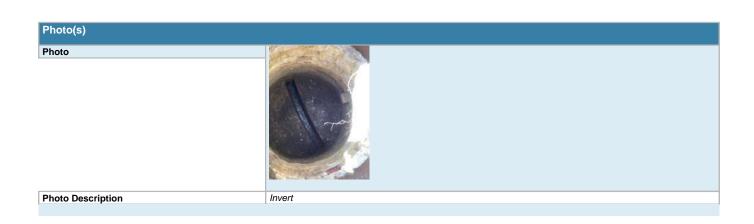
Record: 49	
Client	Village of Tuxedo Park, New York
Project Title	Village of Tuxedo Park Trunk Sewer Inspection
Inspection Date	2021-03-23
Inspector	James Salaway
Sewer	Village of Tuxedo Park Trunk Sewer
Manhole	17-0020MMH
Location	W Lake Stable Road
Street or Easement	Other
Other Manhole Location	Off road next to wall
Surface Type	Other
Other Surface Type	Dirt mound
MH Inspection Status	Inspected
Number of Inverts	2
Signs of Surcharge	NO
Surge Plate	NO
Cover Type	Other
Other Cover Type	Standard small
Cover Material	Cast Iron
Cover Condition	OK
Frame Material	Cast Iron
Frame Condition	OK
MH Cover Elevation At Grade	Above Grade
Cover Inflow	None
MH cleaning Required	NO
MH Grease Visible	NO
Roots	NO
Steps	NO
Steps Condition	Needs Repair
Chimney Material	Brick
Chimney Condition	Satisfactory
Chimney Infiltration	None
Cone Material	Brick
Cone Condition	Satisfactory
Cone Infiltration	None
Wall Material	Brick
Wall Condition	Satisfactory

Wall Infiltration	None
Bench and Invert Material	Brick
Bench and Invert Condition	Satisfactory
Bench and Invert Infiltration	None
Pipe Connection Infiltration	None
Additional Comments	Used before for meterimg
Location Coordinates (click white space below to obtain)	Latitude:41.211793, Longitude:-74.201117, Altitude:164.237681, Speed:0.022814, Horizontal Accuracy:5.229168, Vertical Accuracy:12.675818,
	Vertical Accuracy:12.6/3818, Time:03/23/2021 14:03:46 EDT

Photo(s)		
Photo		
Photo Description	Cover and frame

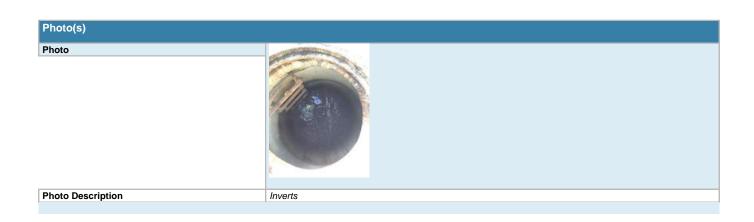
Record: 19	
Client	Village of Tuxedo Park, New York
Project Title	Village of Tuxedo Park Trunk Sewer Inspection
Inspection Date	2021-03-23
Inspector	James Salaway
Sewer	Village of Tuxedo Park Trunk Sewer
Manhole	East-0010
Location	Wee Wah Road
Street or Easement	Street
Surface Type	Asphalt
MH Inspection Status	Inspected
Number of Inverts	2
Signs of Surcharge	NO
Surge Plate	NO
Cover Type	Standard
Cover Material	Cast Iron
Cover Condition	OK
Frame Material	Cast Iron
Frame Condition	OK
MH Cover Elevation At Grade	At Grade
Cover Inflow	None
MH cleaning Required	NO
MH Grease Visible	NO
Roots	NO
Steps	YES
Steps Condition	Satisfactory
Chimney Material	Precast
Chimney Condition	Satisfactory
Chimney Infiltration	None
Cone Material	Precast
Cone Condition	Satisfactory
Cone Infiltration	None
Wall Material	Precast
Wall Condition	Satisfactory
Wall Infiltration	None
Bench and Invert Material	Concrete
Bench and Invert Condition	Satisfactory

Bench and Invert Infiltration	None
Pipe Connection Infiltration	Minimal
Additional Comments	Flow is high in bench, seems to flow over entire base
Location Coordinates (click white space below to obtain)	Latitude:41.219662, Longitude:-74.191674, Altitude:153.580240, Speed:0.004530, Horizontal Accuracy:3.582748, Vertical Accuracy:9.254294, Time:03/23/2021 09:49:02 EDT

Photo(s)	
Photo	
Photo Description	Cover and frame

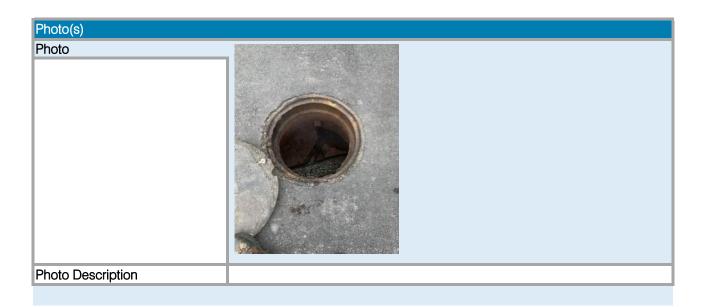
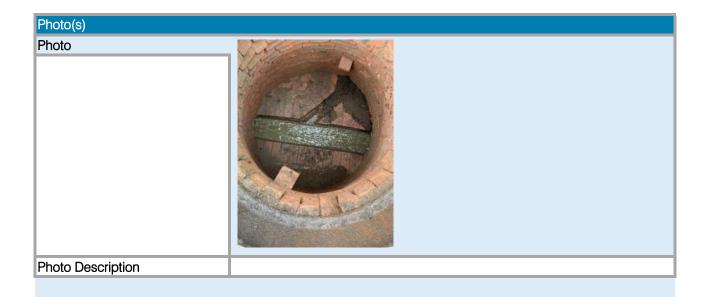
Record: 68	
	Will of Total Data No. 1
Client	Village of Tuxedo Park, New York
Project Title	Village of Tuxedo Park Trunk Sewer Inspection
Inspection Date	2021-03-17
Inspector	Anton Patton
Sewer	Village of Tuxedo Park Trunk Sewer
Manhole	EAST-0040
Location	Continental Road
Street or Easement	Street
Surface Type	Asphalt
MH Inspection Status	Inspected
Number of Inverts	3
Signs of Surcharge	NO
Surge Plate	NO
Cover Type	Standard
Cover Material	Cast Iron
Cover Condition	OK
Frame Material	Cast Iron
Frame Condition	OK
Riser Rings	Other
Other Number of Riser Rings	0
MH Cover Elevation At Grade	At Grade
Cover Inflow	None
MH cleaning Required	YES
MH Grease Visible	NO
Roots	NO
Steps	NO
Chimney Material	Brick
Chimney Condition	Satisfactory
Chimney Infiltration	None
Cone Material	Brick
Cone Condition	Needs Repair
Cone Infiltration	None
Wall Material	Brick
Wall Condition	Satisfactory
Wall Infiltration	None
Bench and Invert Material	Brick
Bench and Invert Condition	Satisfactory

Bench and Invert Infiltration	None
Pipe Connection Infiltration	None
Location Coordinates (click white space below to	
obtain)

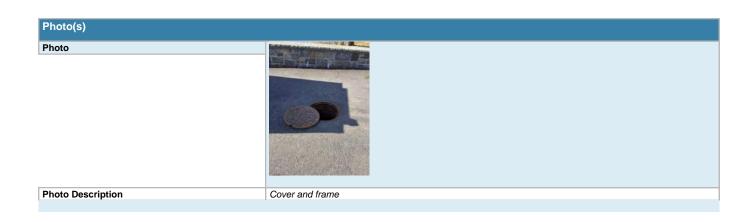
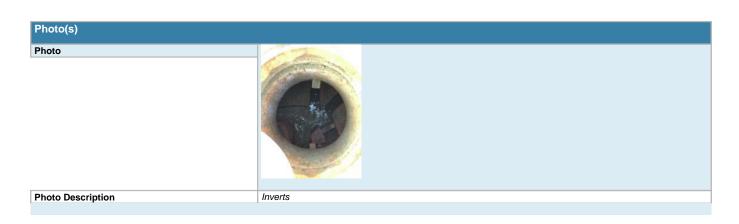
Record: 16	
Client	Village of Tuxedo Park, New York
Project Title	Village of Tuxedo Park Trunk Sewer Inspection
Inspection Date	2021-03-23
Inspector	James Salaway
Sewer	Village of Tuxedo Park Trunk Sewer
Manhole	East-0100
Location	Wee Wah Road
Street or Easement	Street
Surface Type	Asphalt
MH Inspection Status	Inspected
Number of Inverts	4
Signs of Surcharge	NO
Surge Plate	NO
Cover Type	Standard
Cover Material	Cast Iron
Cover Condition	OK
Frame Material	Cast Iron
Frame Condition	OK
MH Cover Elevation At Grade	At Grade
Cover Inflow	None
MH cleaning Required	NO
MH Grease Visible	NO
Roots	NO
Steps	NO
Steps Condition	Needs Repair
Chimney Material	Brick
Chimney Condition	Satisfactory
Chimney Infiltration	None
Cone Material	Brick
Cone Condition	Satisfactory
Cone Infiltration	None
Wall Material	Brick
Wall Condition	Satisfactory
Wall Infiltration	None
Bench and Invert Material	Brick
Bench and Invert Condition	Satisfactory
Bench and Invert Infiltration	None

Pipe Connection Infiltration	None
Location Coordinates (click white space below to obtain)	Latitude:41.219695, Longitude:-74.191704, Altitude:152.146018, Speed:0.006775, Horizontal Accuracy:4.018524,
	Vertical Accuracy:10.102773, Time:03/23/2021 09:37:34 EDT

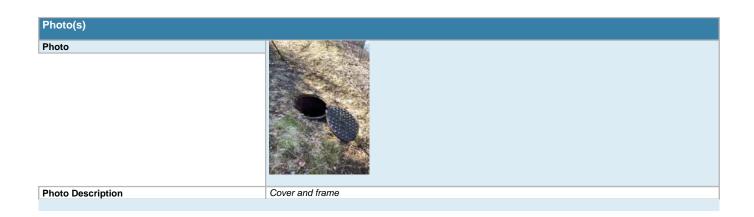
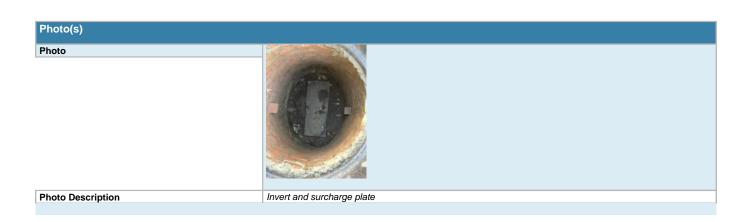
Record: 22	
Client	Village of Tuxedo Park, New York
Project Title	Village of Tuxedo Park Trunk Sewer Inspection
Inspection Date	2021-03-23
Inspector	James Salaway
Sewer	Village of Tuxedo Park Trunk Sewer
Manhole	East-0430
Location	E Lake Road
Street or Easement	Other
Other Manhole Location	Inside fence on property 20' from lake
Surface Type	Grass
MH Inspection Status	Inspected
Number of Inverts	2
Signs of Surcharge	NO
Surge Plate	YES
Cover Type	Standard
Cover Material	Cast Iron
Cover Condition	OK
Frame Material	Cast Iron
Frame Condition	OK
MH Cover Elevation At Grade	At Grade
Cover Inflow	Minimal
MH cleaning Required	NO
MH Grease Visible	NO
Roots	NO
Steps	NO
Steps Condition	Needs Repair
Chimney Material	Brick
Chimney Condition	Satisfactory
Chimney Infiltration	None
Cone Material	Brick
Cone Condition	Satisfactory
Cone Infiltration	None
Wall Material	Brick
Wall Condition	Satisfactory
Wall Infiltration	None
Bench and Invert Material	Brick

Bench and Invert Condition	Satisfactory
Bench and Invert Infiltration	None
Pipe Connection Infiltration	None
Additional Comments	Surcharge plate, can't see bench or inverts
Location Coordinates (click white space below to	
obtain)	Langitude:-74.202174,  Altitude:176.038877,  Speed:0.003404,
	Horizontal Accuracy:4.320988,  Vertical Accuracy:9.439337,  Time:03/23/2021 10:44:29 EDT

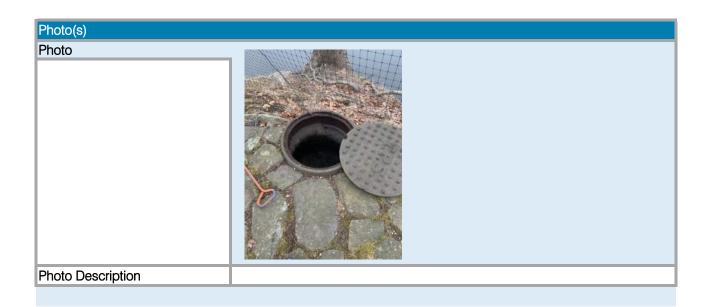
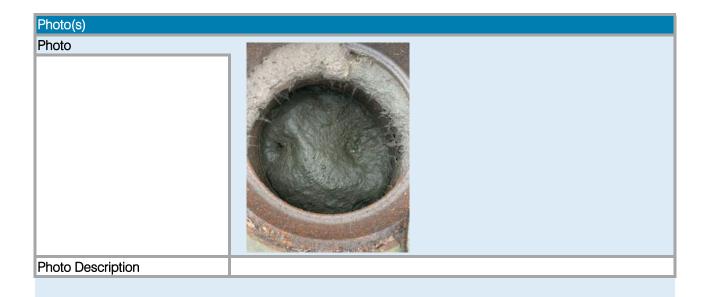
Record: 7	
Client	Village of Tuxedo Park, New York
Project Title	Village of Tuxedo Park Trunk Sewer Inspection
Inspection Date	2021-03-17
Inspector	Anton Patton
Sewer	Village of Tuxedo Park Trunk Sewer
Manhole	East-0440
Location	E Lake Road
Street or Easement	Easement
Surface Type	Other
Other Surface Type	Slate Path
MH Inspection Status	Inspected
Cover Type	Standard
Cover Material	Cast Iron
Cover Condition	OK
Frame Material	Cast Iron
Frame Condition	OK
Riser Rings	Other
Other Number of Riser Rings	0
MH Cover Elevation At Grade	At Grade
MH cleaning Required	YES
Additional Comments	Manhole filled almost to top with silty mud/muck. Could not see enough for thorough inspection.
Location Coordinates (click white space below to obtain)

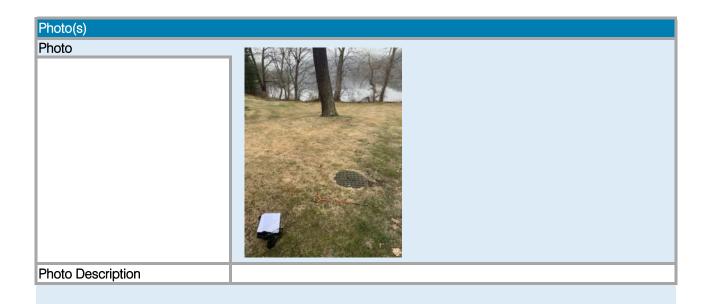
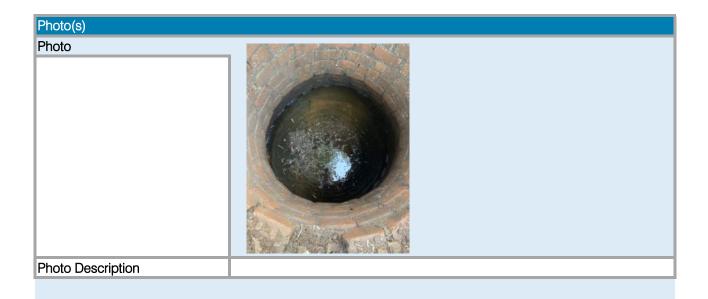
Record: 10	
	Will of Total Dalah Will
Client	Village of Tuxedo Park, New York
Project Title	Village of Tuxedo Park Trunk Sewer Inspection
Inspection Date	2021-03-17
Inspector	Anton Patton
Sewer	Village of Tuxedo Park Trunk Sewer
Manhole	East-0450
Location	E Lake Road
Street or Easement	Easement
Surface Type	Grass
MH Inspection Status	Inspected
Signs of Surcharge	NO
Surge Plate	YES
Cover Type	Standard
Cover Material	Cast Iron
Cover Condition	OK
Frame Material	Cast Iron
Frame Condition	OK
Riser Rings	Other
Other Number of Riser Rings	0
MH Cover Elevation At Grade	At Grade
Cover Inflow	Minimal
MH cleaning Required	YES
MH Grease Visible	NO
Roots	YES
Steps	NO
Chimney Material	Brick
Chimney Condition	Satisfactory
Chimney Infiltration	Minimal
Cone Material	Brick
Cone Condition	Satisfactory
Cone Infiltration	Minimal
Wall Material	Brick
Wall Condition	Satisfactory
Wall Infiltration	Minimal
Bench and Invert Material	Brick
Bench and Invert Condition	Satisfactory

Bench and Invert Infiltration	None
Pipe Connection Infiltration	None
Additional Comments	Filled with 2' of water.
Location Coordinates (click white space below to	
obtain)

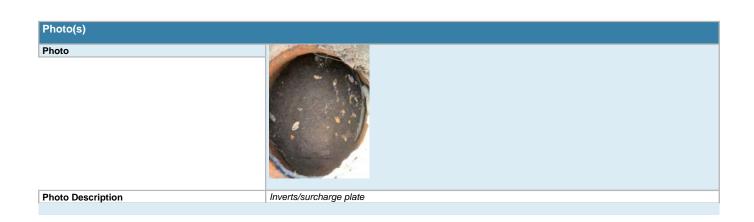
Client Project Title	Village of Tuxedo Park, New York
•	VIII (T. I.D. IT. I.O. I. III
	Village of Tuxedo Park Trunk Sewer Inspection
Inspection Date	2021-03-23
Inspector	James Salaway
Sewer	Village of Tuxedo Park Trunk Sewer
Manhole	East-0460
Location	E Lake Road
Street or Easement	Other
Other Manhole Location	Dequestashia property 15' off lake
Surface Type	Grass
MH Inspection Status	Inspected
Number of Inverts	2
Signs of Surcharge	NO
Surge Plate	YES
Cover Type	Standard
Cover Material	Cast Iron
Cover Condition	OK
Frame Material	Cast Iron
Frame Condition	OK
	At Grade
	Minimal
MH cleaning Required	YES
<u> </u>	NO
Roots	YES
	NO NO
	Needs Repair
<u> </u>	Brick
Chimney Condition	Satisfactory
	None
· · · · · · · · · · · · · · · · · · ·	Brick
Cone Condition	Satisfactory
	None
	Brick
Wall Condition	Satisfactory
	None
	Brick
Bench and Invert Condition	Satisfactory
	None
	None
Additional Comments	Surcharge plate, can't see bench and invert

Photo(s)	
Photo	
Photo Description	Cover and frame

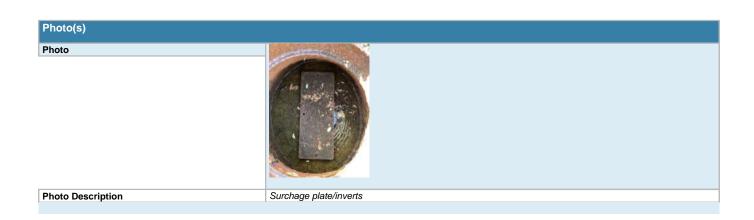
Record: 31	
Client	Village of Tuxedo Park, New York
Project Title	Village of Tuxedo Park Trunk Sewer Inspection
Inspection Date	2021-03-23
Inspector	James Salaway
Sewer	Village of Tuxedo Park Trunk Sewer
Manhole	East-0470
Location	E Lake Road
Street or Easement	Other
Other Manhole Location	Burke backyard in brush 30' from lake
Surface Type	Grass
MH Inspection Status	Inspected
Number of Inverts	2
Signs of Surcharge	NO
Surge Plate	YES
Cover Type	Standard
Cover Material	Cast Iron
Cover Condition	OK
Frame Material	Cast Iron
Frame Condition	OK
MH Cover Elevation At Grade	At Grade
Cover Inflow	None
MH cleaning Required	YES
MH Grease Visible	NO
Roots	YES
Steps	NO
Steps Condition	Needs Repair
Chimney Material	Brick
Chimney Condition	Satisfactory
Chimney Infiltration	Minimal
Cone Material	Brick
Cone Condition	Satisfactory
Cone Infiltration	None
Wall Material	Brick
Wall Condition	Satisfactory
Wall Infiltration	None
Bench and Invert Material	Brick

Bench and Invert Condition	Satisfactory
Bench and Invert Infiltration	None
Pipe Connection Infiltration	None
Additional Comments	Surcharge plate can't see inverts
Location Coordinates (click white space below to	Latitude:41.197912,
obtain)	Longitude:-74.202650,
,	Altitude:175.604614,
	Speed:0.012688,
	Horizontal Accuracy:4.875705,
	Vertical Accuracy:11.101611,
	Time:03/23/2021 11:46:13 EDT

Photo(s)		
Photo		
Photo Description	Cover and frame

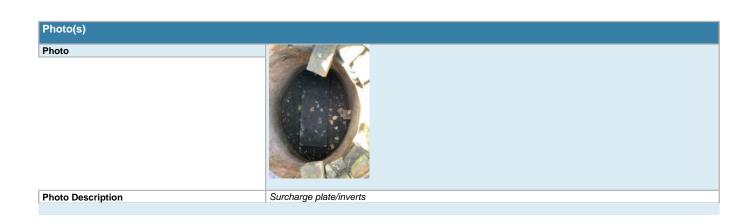
Record: 34	
Client	Village of Tuxedo Park, New York
Project Title	Village of Tuxedo Park Trunk Sewer Inspection
Inspection Date	2021-03-23
Inspector	James Salaway
Sewer	Village of Tuxedo Park Trunk Sewer
Manhole	East-0480
Location	E Lake Road
Street or Easement	Other
Other Manhole Location	Burke backyard open yard 25' from lake
Surface Type	Grass
MH Inspection Status	Inspected
Number of Inverts	2
Signs of Surcharge	NO
Surge Plate	YES
Cover Type	Standard
Cover Material	Cast Iron
Cover Condition	OK
Frame Material	Cast Iron
Frame Condition	OK .
MH Cover Elevation At Grade	At Grade
Cover Inflow	Minimal
MH cleaning Required	NO
MH Grease Visible	NO
Roots	NO
Steps	NO
Chimney Material	Brick
Chimney Condition	Needs Repair
Chimney Infiltration	None
Cone Material	Brick
Cone Condition	Needs Repair
Cone Infiltration	None None
Wall Material	None Brick
	·
Wall Condition	Needs Repair
Wall Infiltration	None
Bench and Invert Material	Brick
Bench and Invert Condition	Satisfactory

Bench and Invert Infiltration	None
Pipe Connection Infiltration	None
Additional Comments	Surcharge plate, can't see inverts
Location Coordinates (click white space below to obtain)	Latitude:41.197450, Longitude:-74.203203, Altitude:173.144448, Speed:0.022388.
	Horizontal Accuracy:3.864647,  Vertical Accuracy:9.966428,  Time:03/23/2021 11:52:29 EDT

Photo	
- A	
Photo Description Cove

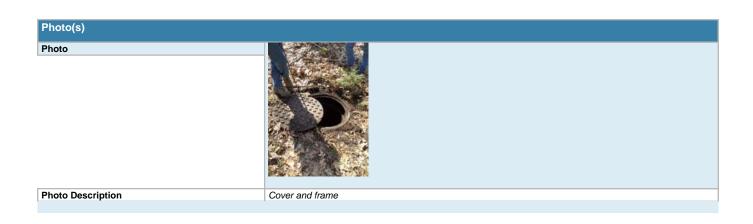
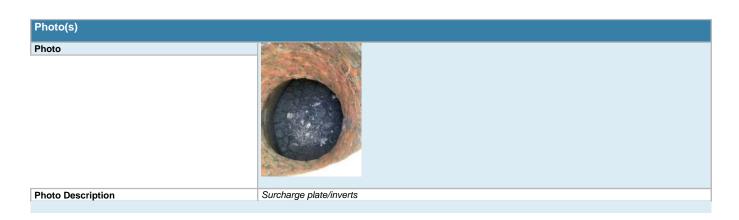
Record: 37	
Client	Village of Tuxedo Park, New York
Project Title	Village of Tuxedo Park Trunk Sewer Inspection
Inspection Date	2021-03-23
Inspector	James Salaway
Sewer	Village of Tuxedo Park Trunk Sewer
Manhole	East-500
Location	E Lake Road
Street or Easement	Other
Other Manhole Location	Between burke and brick house, in woods
Surface Type	Grass
MH Inspection Status	Inspected
Number of Inverts	3
Signs of Surcharge	NO
Surge Plate	YES
Cover Type	Standard
Cover Material	Cast Iron
Cover Condition	OK
Frame Material	Cast Iron
Frame Condition	OK
MH Cover Elevation At Grade	At Grade
Cover Inflow	None
MH cleaning Required	YES
MH Grease Visible	NO
Roots	YES
Steps	NO
Steps Condition	Needs Repair
Chimney Material	Brick
Chimney Condition	Satisfactory
Chimney Infiltration	None
Cone Material	Brick
Cone Condition	Satisfactory
Cone Infiltration	None
Wall Material	Brick
Wall Condition	Satisfactory
Wall Infiltration	None
Bench and Invert Material	Brick

Bench and Invert Condition	Satisfactory
Bench and Invert Infiltration	None
Pipe Connection Infiltration	None
Additional Comments	Surcharge plate, can't see inverts
Location Coordinates (click white space below to obtain)	Latitude:41.196621, Longitude:-74.203644,
,	Altitude:174.405518,
	Speed:0.006142.
	Horizontal Accuracy:4.738896,
	Vertical Accuracy:11.637528,
	Time:03/23/2021 12:08:51 EDT

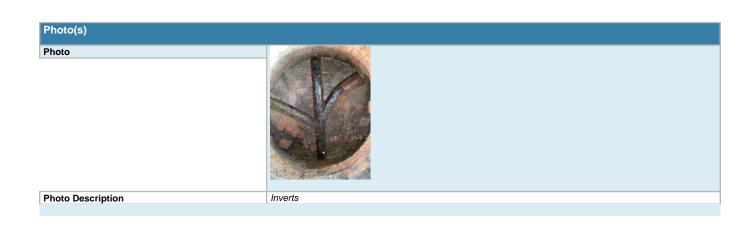
Client	Village of Tuxedo Park, New York
Project Title	Village of Tuxedo Park Trunk Sewer Inspection
Inspection Date	2021-03-23
Inspector	James Salaway
Sewer	Village of Tuxedo Park Trunk Sewer
Manhole	East-1160
Location	E Lake Road
Street or Easement	Other
Other Manhole Location	Cindy booth house
Surface Type	Grass
MH Inspection Status	Inspected
Number of Inverts	4
Signs of Surcharge	NO
Surge Plate	NO NO
Cover Type	Standard
Cover Naterial	Cast Iron
Cover Condition	OK
Frame Material	Cast Iron
Frame Condition	OK
MH Cover Elevation At Grade	At Grade
Cover Inflow	None
MH cleaning Required	NO
MH Grease Visible	NO NO
Roots	YES
Steps	NO
Steps Condition	Needs Repair
	Brick
Chimney Material	
Chimney Condition	Needs Repair None
Chimney Infiltration Cone Material	Brick
Cone Condition	
Cone Condition  Cone Infiltration	Needs Repair
	None
Wall Material	Brick
Wall Infiltration	Needs Repair
Wall Infiltration	None
Bench and Invert Material Bench and Invert Condition	Brick Setiologies

Satisfactory
Bench and Invert Infiltration	None
Pipe Connection Infiltration	None
Location Coordinates (click white space below to obtain)	Latitude:41.203997, Longitude:74.201384, Altitude:185.169987, Speed:0.009490, Horizontal Accuracy:4.900740,
	Vertical Accuracy: 4.900740,  Vertical Accuracy: 12.775071,  Time: 03/23/2021 15:02:21 EDT

Photo(s)	
Photo	
Photo Description	Cover and frame

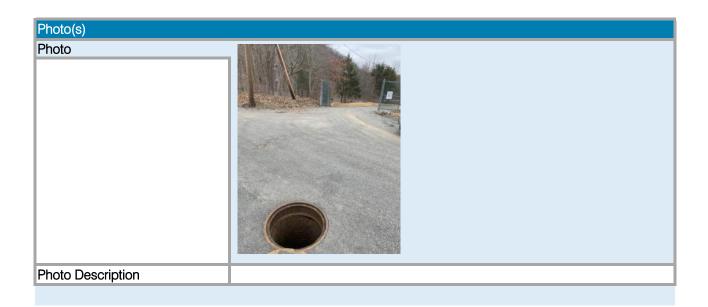
Record: 65	
Client	Village of Tuxedo Park, New York
Project Title	Village of Tuxedo Park Trunk Sewer Inspection
Inspection Date	2021-03-17
Inspector	Anton Patton
Sewer	Village of Tuxedo Park Trunk Sewer
Manhole	VIL-0100
Location	Wee Wah Road
Street or Easement	Street
Surface Type	Asphalt
MH Inspection Status	Inspected
Number of Inverts	4
Signs of Surcharge	NO
Surge Plate	NO
Cover Type	Standard
Cover Material	Cast Iron
Cover Condition	OK
Frame Material	Cast Iron
Frame Condition	OK
Riser Rings	Other
Other Number of Riser Rings	0
MH Cover Elevation At Grade	At Grade
Cover Inflow	None
MH cleaning Required	NO
MH Grease Visible	NO
Roots	NO
Steps	NO
Chimney Material	Brick
Chimney Condition	Satisfactory
Chimney Infiltration	None
Cone Material	Brick
Cone Condition	Satisfactory
Cone Infiltration	None
Wall Material	Brick
Wall Condition	Satisfactory
Wall Infiltration	None
Bench and Invert Material	Brick
Bench and Invert Condition	Satisfactory

Bench and Invert Infiltration	None
Pipe Connection Infiltration	None
Location Coordinates (click white space below to	
obtain)

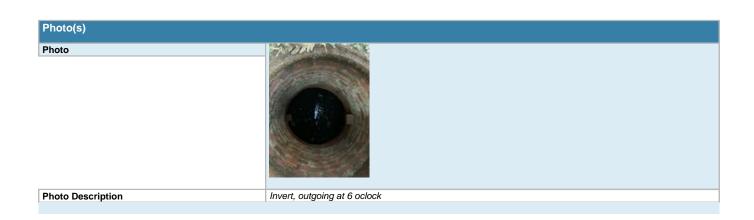
Becaute 42	
Record: 13	
Client	Village of Tuxedo Park, New York
Project Title	Village of Tuxedo Park Trunk Sewer Inspection
Inspection Date	2021-03-17
Inspector	Anton Patton
Sewer	Village of Tuxedo Park Trunk Sewer
Manhole	West-0190
Location	W Lake Stable Road
Street or Easement	Easement
Surface Type	Grass
MH Inspection Status	Inspected
Number of Inverts	2
Signs of Surcharge	YES
Surge Plate	NO
Cover Type	Other
Other Cover Type	Small 17"
Cover Material	Cast Iron
Cover Condition	OK
Frame Material	Cast Iron
Frame Condition	OK
Riser Rings	1
MH Cover Elevation At Grade	Above Grade
Cover Inflow	None
MH cleaning Required	YES
MH Grease Visible	NO
Roots	YES
Steps	NO
Chimney Material	Brick
Chimney Condition	Satisfactory
Chimney Infiltration	Minimal
Cone Material	Brick
Cone Condition	Satisfactory
Cone Infiltration	Minimal
Wall Material	Brick
Wall Condition	Satisfactory
Wall Infiltration	Minimal
Bench and Invert Material	Brick
Bench and Invert Condition	Satisfactory

Bench and Invert Infiltration	Minimal
Pipe Connection Infiltration	None
Location Coordinates (click white space below to	
obtain)

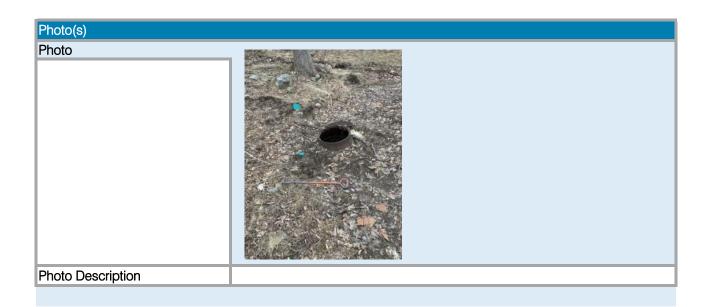
VIII (T. I.D.I.N. V.I.
Client	Village of Tuxedo Park, New York
Project Title	Village of Tuxedo Park Trunk Sewer Inspection
Inspection Date	2021-03-17
Inspector	Anton Patton
Sewer	Village of Tuxedo Park Trunk Sewer
Manhole	West-0200
Location	W Lake Stable Road
Street or Easement	Easement
Surface Type	Grass
MH Inspection Status	Inspected
Number of Inverts	2
Signs of Surcharge	YES
Surge Plate	NO
Cover Type	Standard
Other Cover Type	Small 17"
Cover Material	Cast Iron
Cover Condition	OK
Frame Material	Cast Iron
Frame Condition	OK
Riser Rings	Other
Other Number of Riser Rings	0
MH Cover Elevation At Grade	Above Grade
Cover Inflow	None
MH cleaning Required	YES
MH Grease Visible	NO
Roots	YES
Steps	NO
Chimney Material	Brick
Chimney Condition	Satisfactory
Chimney Infiltration	Minimal
Cone Material	Brick
Cone Condition	Satisfactory
Cone Infiltration	Minimal
Wall Material	Brick
Wall Condition	Satisfactory
Wall Infiltration	Minimal
Bench and Invert Material	Brick

Bench and Invert Condition	Satisfactory
Bench and Invert Infiltration	None
Pipe Connection Infiltration	None
Additional Comments	Inflow likely dependent on lake water level.
Location Coordinates (click white space below obtain)

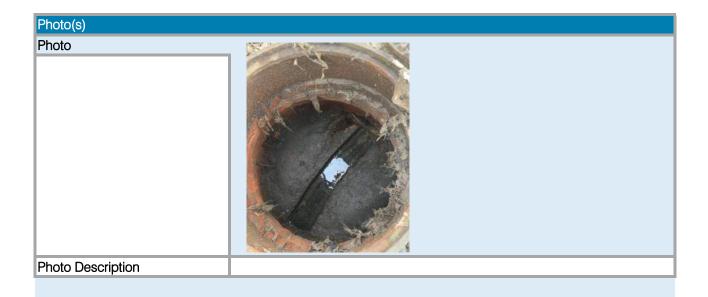
Record: 59	
Client	Village of Tuxedo Park, New York
Project Title	Village of Tuxedo Park Trunk Sewer Inspection
Inspection Date	2021-03-17
Inspector	Anton Patton
Sewer	Village of Tuxedo Park Trunk Sewer
Manhole	West-0220
Location	W Lake Stable Road
Street or Easement	Easement
Surface Type	Grass
MH Inspection Status	Inspected
Number of Inverts	2
Signs of Surcharge	NO
Surge Plate	YES
Cover Type	Standard
Other Cover Type	Small 17"
Cover Material	Cast Iron
Cover Condition	OK
Frame Material	Cast Iron
Frame Condition	OK
Riser Rings	Other
Other Number of Riser Rings	0
MH Cover Elevation At Grade	At Grade
Cover Inflow	None
MH cleaning Required	YES
MH Grease Visible	NO
Roots	NO
Steps	NO
Chimney Material	Brick
Chimney Condition	Satisfactory
Chimney Infiltration	None
Cone Material	Brick
Cone Condition	Satisfactory
Cone Infiltration	None
Wall Material	Brick
Wall Condition	Satisfactory
Wall Infiltration	None
Bench and Invert Material	Brick

Bench and Invert Condition	Satisfactory
Bench and Invert Infiltration	None
Pipe Connection Infiltration	None
Location Coordinates (click white space below to obtain)

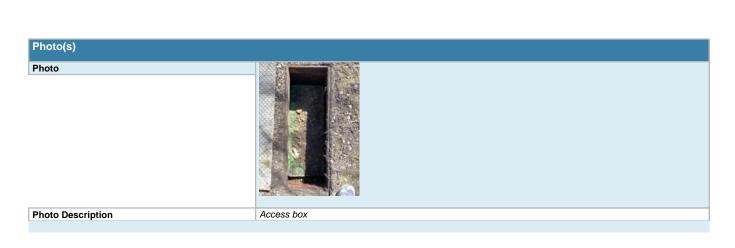
Record: 46	
Client	Village of Tuxedo Park, New York
Project Title	Village of Tuxedo Park Trunk Sewer Inspection
Inspection Date	2021-03-23
Inspector	James Salaway
Sewer	Village of Tuxedo Park Trunk Sewer
Manhole	West-0270
Location	W Lake Stable Road
Street or Easement	Other
Other Manhole Location	Behind brown white house, trampolie, access box
Surface Type	Grass
MH Inspection Status	Inspected
Signs of Surcharge	NO
Surge Plate	YES
Cover Type	Other
Other Cover Type	Access box to line
Cover Material	Other
Other Cover Material	Iron rectangle
Cover Condition	OK
Frame Material	Cast Iron
Frame Condition	OK
MH Cover Elevation At Grade	At Grade
Cover Inflow	None
MH cleaning Required	NO
MH Grease Visible	NO
Roots	NO NO
Steps	NO
Steps Condition	Satisfactory
Chimney Material	Brick
Chimney Condition	Satisfactory
Chimney Infiltration	None
Cone Material	Brick
Cone Condition	Satisfactory
Cone Infiltration	None
Wall Material	Brick
Wall Condition	Satisfactory

Wall Infiltration	·
Bench and Invert Material	None Brick
Bench and Invert Condition	· ·
	Satisfactory
Bench and Invert Infiltration	None
Pipe Connection Infiltration	None
Additional Comments	Access box, not an actual manhole Latitude:41.209778,
Location Coordinates (click white space below to obtain)	Lautide:41.209776,  Longitude:74.201945,  Altitude:156.794871,  Speed:0.006158,  Horizontal Accuracy:4.233974,
	Vertical Accuracy: 12.353905, Time:03/23/2021 13:37:12 EDT
